Geoelectrical Survey of Historic Silver Mine Area, Suggental 2011-13

Calibration Measurement in the Josephi Tunnel

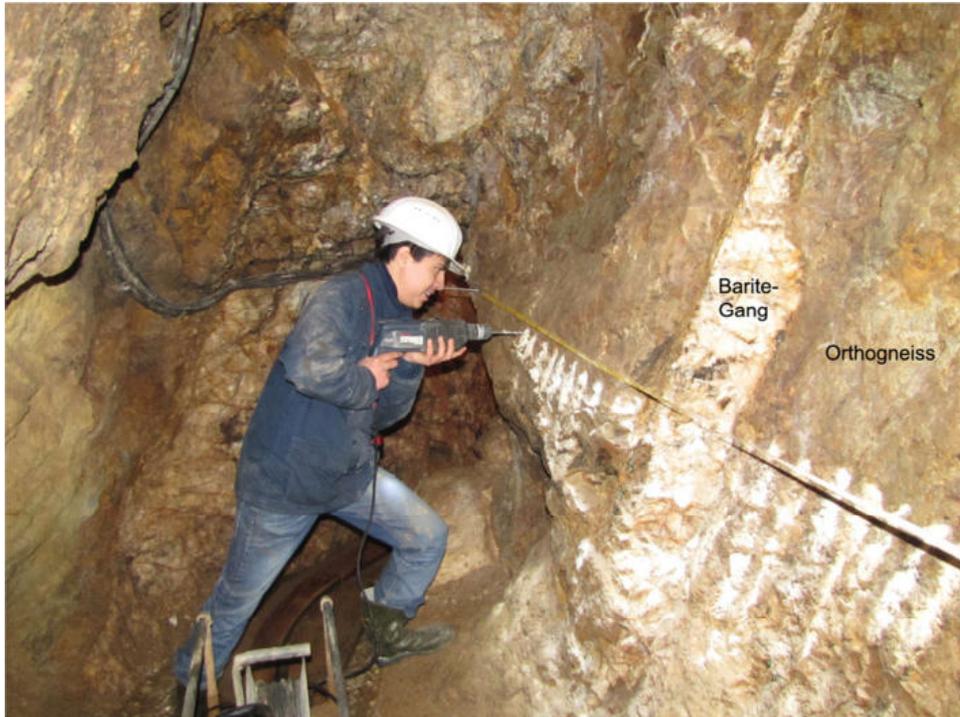
Drill holes for current electrodes; Jonathan (Moll)

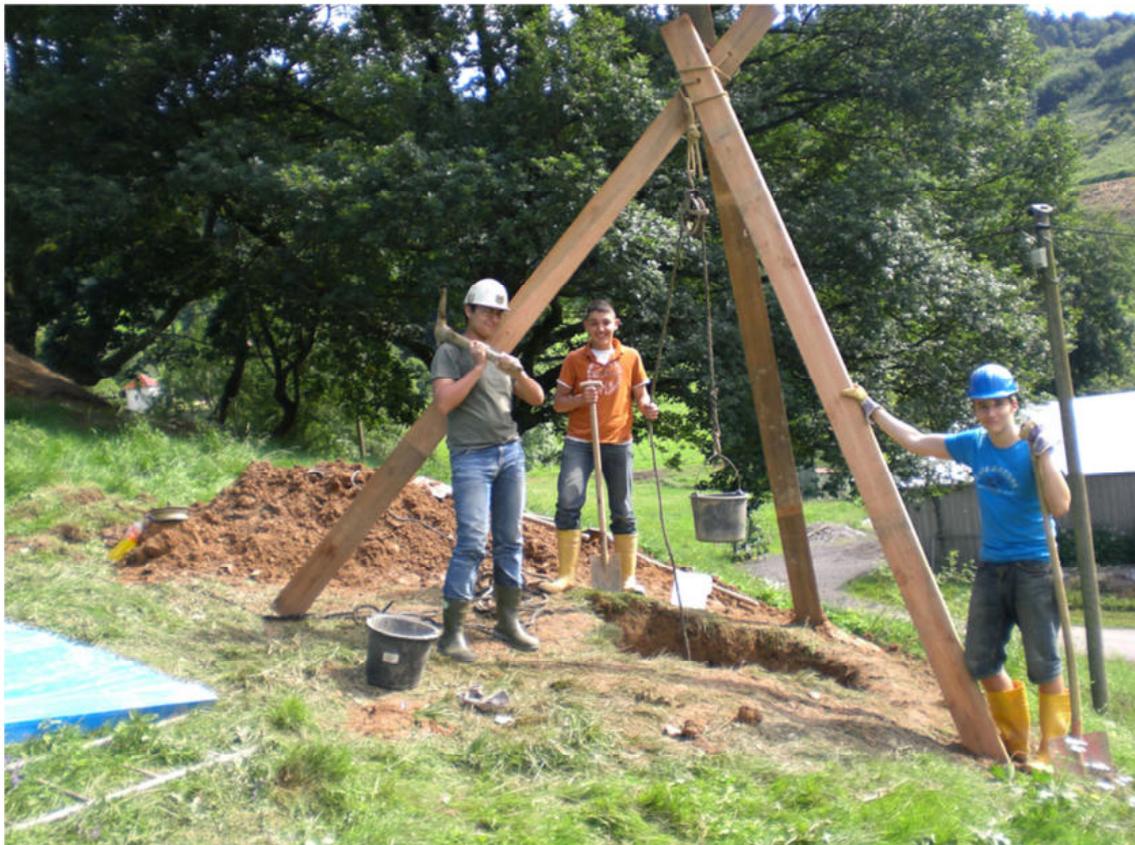
Test Pit: Jonathan, Alper, Jérôme; (Moll)

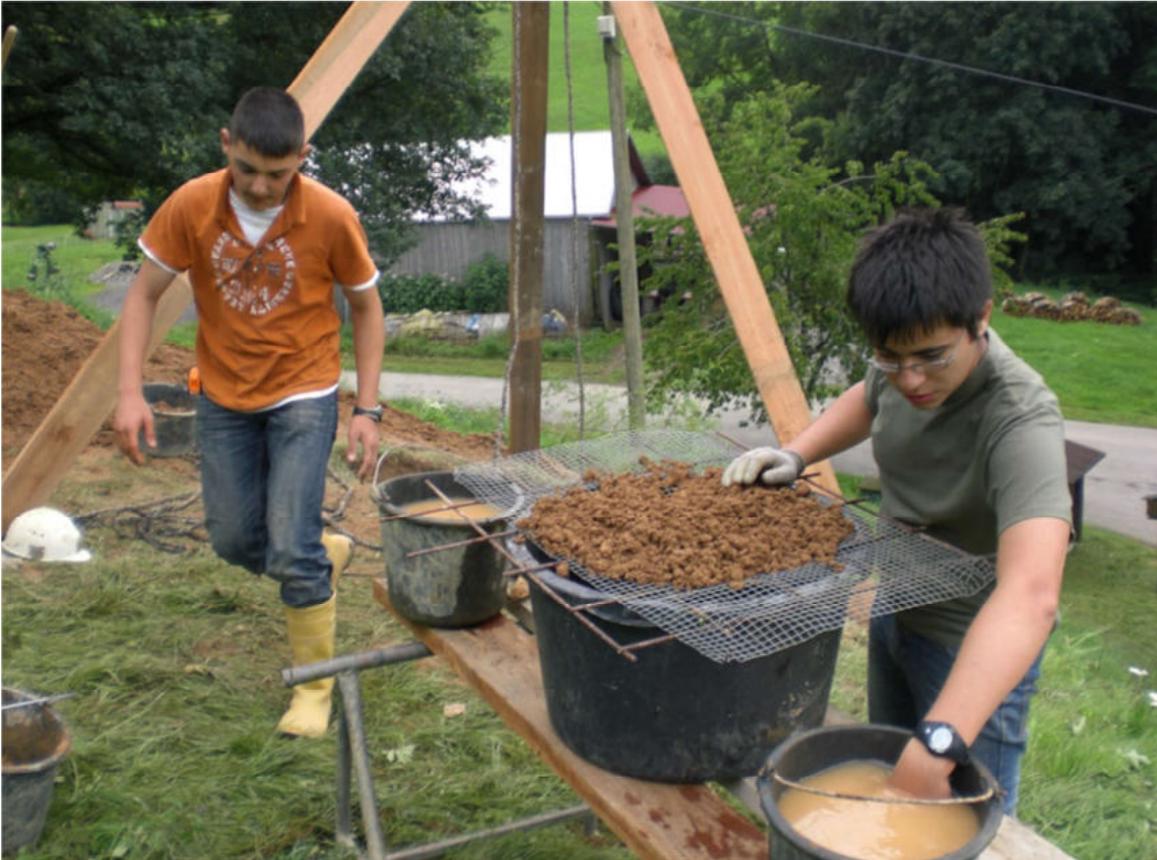
Sieving of excavated material from 1,80 m depth; Alper, Jonathan; (Moll)

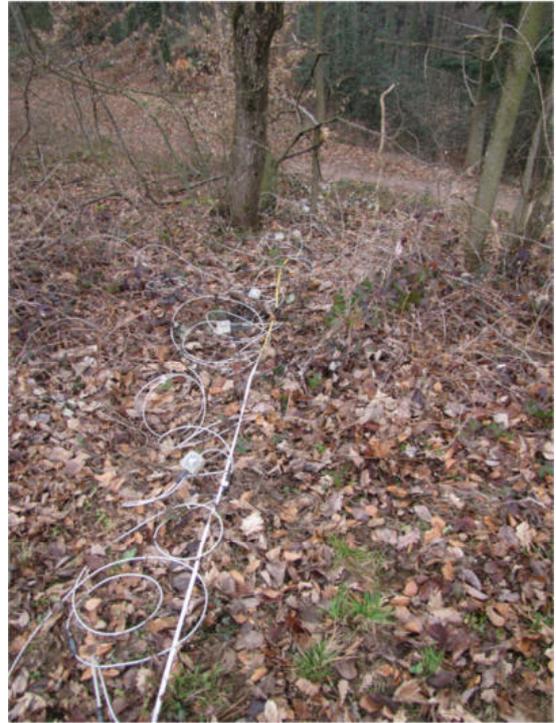
The local orientation of this survey was based on assumptions by current miners that the old Anna Vein might be located in this section. This vein is mentioned in historical records but has not yet been found. The present measurement was therefore conducted to search for this historic vein.
